TECHNICAL MEMORANDUM 84/BB

CORROSION PROBLEMS
IN THE CANADIAN MARITIME FORCES

Defence
Research
Establishment
Atlantic

Edited version of an oral presentation given
at the Seventh Inter-Naval Corrosion Conference,
Canberra, Australia, 10 April 1984.

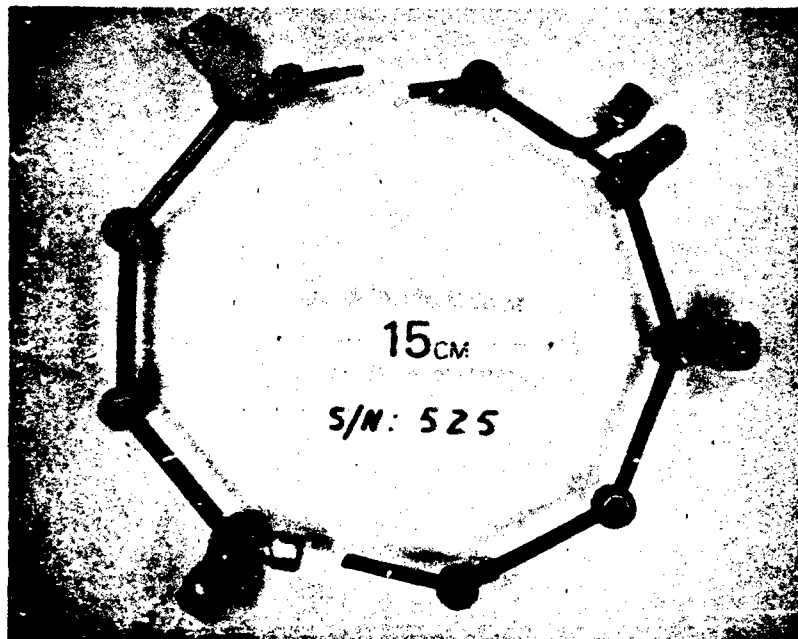
Solar Saturn gas turbines are used to provide auxiliary power onboard the DDH 280 Tribal Class destroyers. During a post engine failure inspection a crack was found in one of the tubes of a fuel manifold (Figures 1 and 2). This unit distributes the fuel to the burner nozzles in the gas turbine.

The fuel manifolds are made of stainless steel (UNS S34700). The surrounding operating temperature is approximately 350°F. A macroscopic examination of the inside of the cracked tube showed the presence of numerous microcracks that contained chlorides (Figure 3). Seawater, the source of chlorides, is an inevitable contaminant which enters the fuel tanks through faulty valves. It is normally removed from the fuel through gravity, centrifuges and coalescers.

An investigation into the operation of the fuel transfer system revealed that the coalescer units had not been installed properly and that seawater was not being removed from the fuel. This problem was corrected and there have been no further failures of the fuel manifolds.

Figure 1 Cracked stainless steel Solar Saturn fuel manifold.

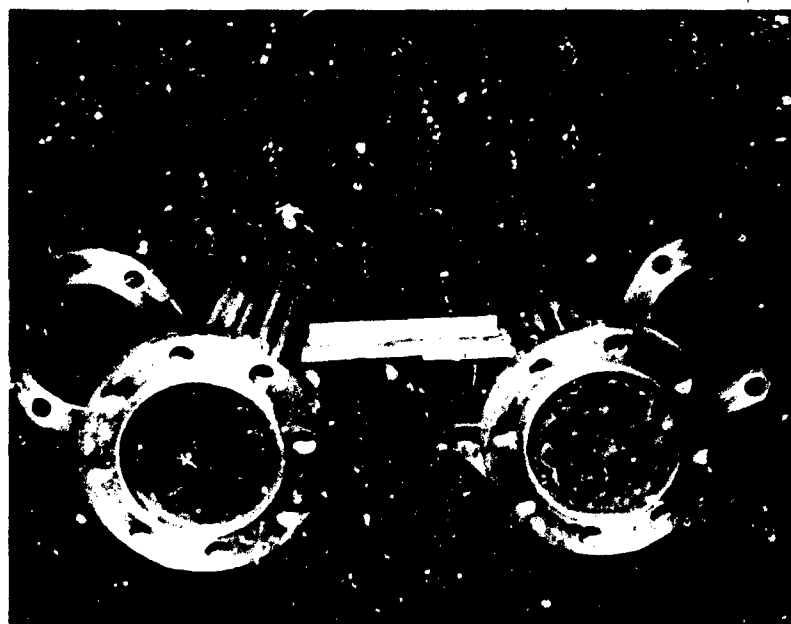
Another problem has been the cracking in the desuperheater tubes in two AOR ships: HMCS Preserver and HMCS Protecteur (Figure 4).

Figure 4 Austenitic stainless steel desuperheater tube bundle.

It was recommended that the tube material be changed to a lower carbon stainless steel (UNS S30403) to reduce the risk of sensitization, and that a stress relief heat treatment be carried out after either welding or cold bending.

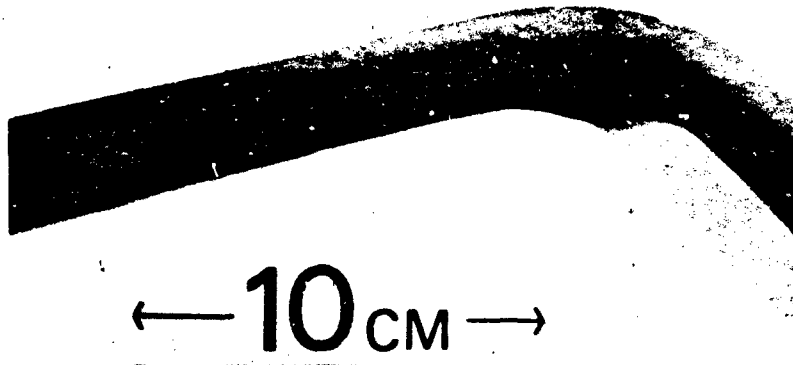
An inspection of the tube bundles revealed cracking in a number of areas on the tubes. Cracks were found near welded tube ends, in areas where changes occurred in the tube diameter, and at 90° bends (Figures 5, 6 and 7).

Figure 7 Crack at 90° bend in stainless steel desuperheater tube.

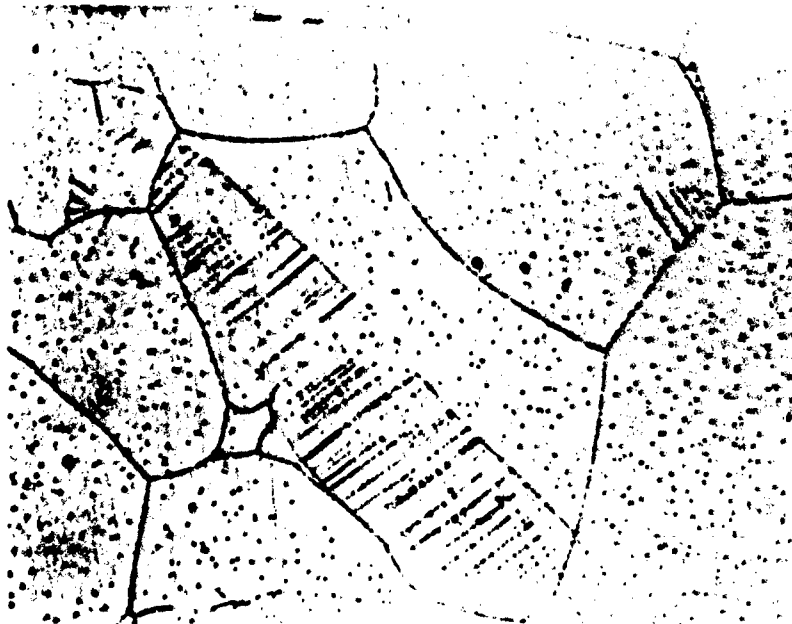
These desuperheater tubes are made of austenitic stainless steel (UNS S30400) and have been in use for approximately 17 years. A metallographic examination revealed that the tubing had experienced some degree of sensitization. The resulting carbide precipitation occurring along grain boundaries and at slip lines can be seen in Figure 8.

Figure 8 Metallograph of austenitic stainless steel desuperheater tube material showing carbide precipitation at grain boundaries and slip lines. X625

Although the operating temperature is only about 200°F, it appears that long term exposure at this temperature results in sensitization. Sensitization in combination with residual stress, increases stainless steel's susceptibility to stress corrosion cracking in the presence of chlorides⁴. Chlorides are a common impurity in marine boiler water and can be carried over in steam when their concentration becomes too high at separators. A metallographic examination showed an extensive intergranular fracture morphology (Figure 9).

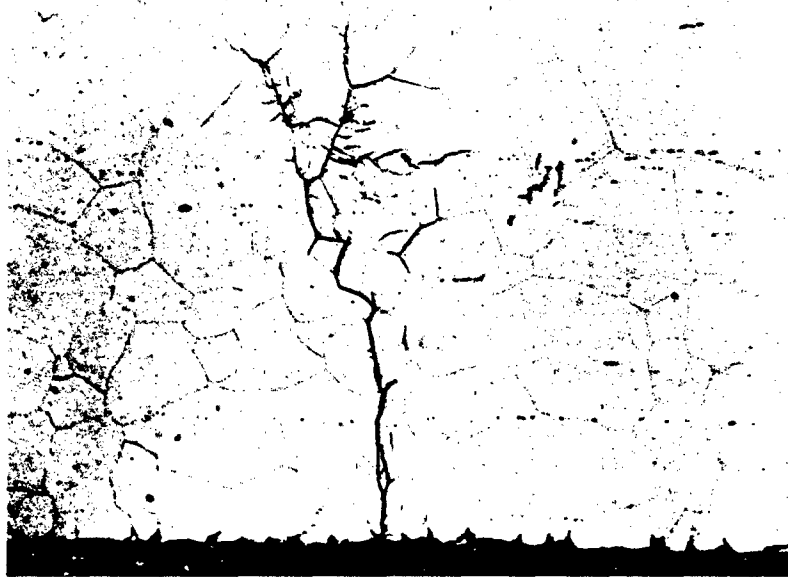
Figure 9 **Metallograph of sensitized stainless steel desuperheater tube material showing resulting stress corrosion cracking. X156**

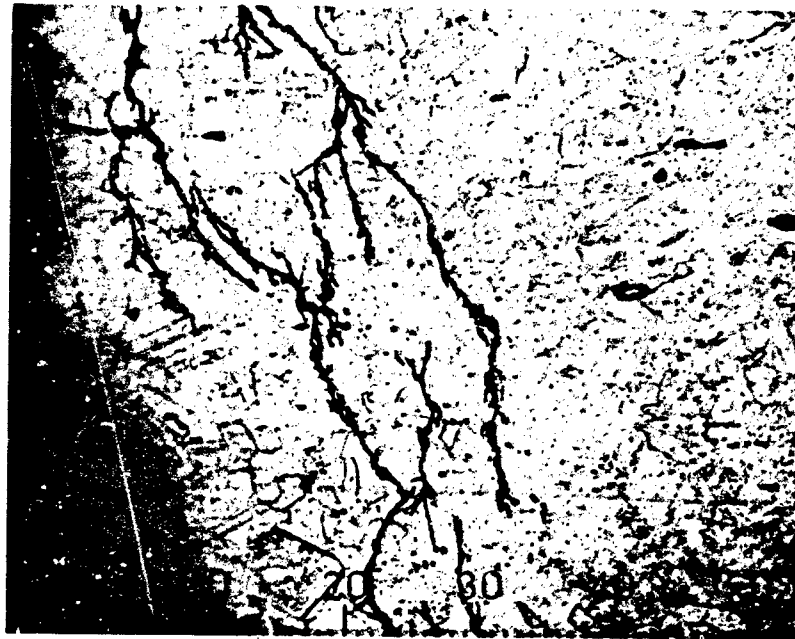
The initial waste heat boiler cores were made of austenitic stainless steel (UNS S34700) tubes (Figure 10). In a very short period of time, these tubes suffered chloride stress corrosion cracking (Figure 11) and had to be replaced. As well as being a common impurity in boiler water, chlorides are also present in the marine atmosphere ingested by the waste heat producing gas turbine engines. The waste heat boiler cores were redesigned and fabricated with mild steel.

Figure 11 Metallograph of original austenitic stainless steel waste heat core material showing mixture of intergranular and transgranular chloride stress corrosion cracking. X125

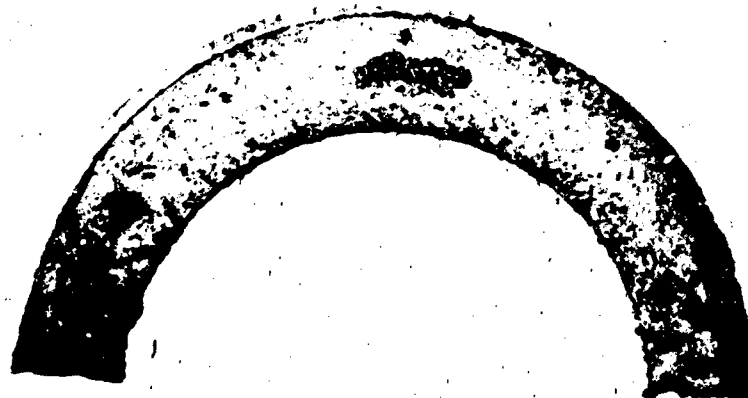
Both the coils of the auxiliary boiler, which have always been mild steel, and the new mild steel waste heat boiler cores were designed to use deoxygenated water. The feedtank they share, however, is open to the atmosphere and the water it supplies is rich in dissolved oxygen. The coils of the auxiliary boiler have had to be replaced approximately every two years since mild steel suffers from oxygen pitting corrosion attack⁵ (Figure 12). It was not long before the new mild steel waste heat boiler cores were also suffering from pitting corrosion attack due to the presence of dissolved oxygen in the boiler water (Figure 13).

Figure 12 Sectioned mild steel auxiliary boiler coil showing oxygen pitting corrosion attack.

A decision has been made to replace the mild steel waste heat cores with ones made of a superior stainless steel (UNS N08028). Although this material will resist both oxygen pitting attack and chloride stress corrosion cracking, the auxiliary boiler coils will continue to corrode due to the presence of oxygen in the feedwater.

Water treatment trials were carried out using sodium sulfite as a dissolved oxygen scavenger, but the results were inconclusive because of coincidental equipment problems. Sodium sulfite should really be used as a residual dissolved oxygen scavenger in conjunction with a mechanical deaerator⁶, but a mechanical deaerator cannot be installed because of space and weight limitations.

Major engineering modifications of the feedwater supply and treatment system would have to take place before a satisfactory solution can be found.

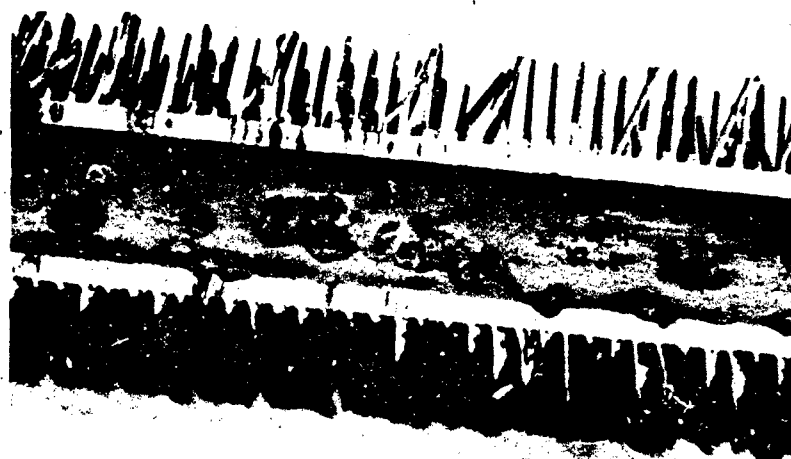
Figure 13 Sectioned mild steel waste heat boiler core showing oxygen pitting corrosion attack.

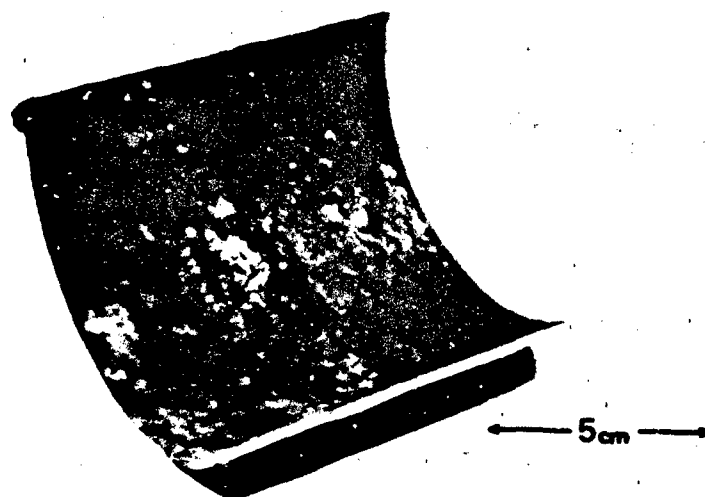
The two primary alloys used in the DDH 280 class firemain systems are 90/10 copper nickel (UNS C70600) (pipe) and leaded tin bronze (UNS C92200) (fittings). The Canadian Forces' experience with the 90/10 alloy has been favourable. There have been, however, a few areas in the DDH 280 class firemain systems that have experienced erosion corrosion damage (Figure 19).

Figure 19 Erosion corrosion of 90/10 copper nickel pipe.

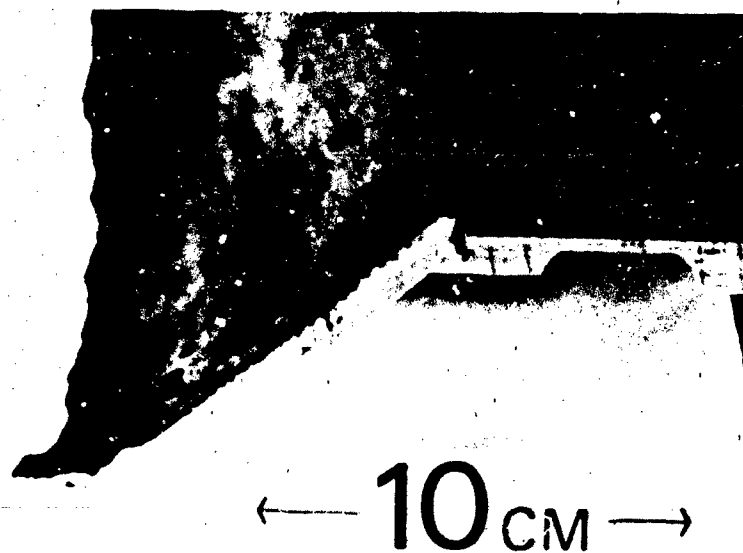
Another problem that has occurred in the past is the introduction of unsuitable and unspecified alloys into the firemain system. One example is a reducer which was required to connect a 5 inch pipe to a 2-1/2 inch pipe. Since a standard reducer could not be found in the stores system, one had to be fabricated in the shops. The material used was naval brass and the component lasted six months before dezincification penetrated the wall of the pipe (Figure 20).

Figure 20 Dezincification of naval brass reducer.

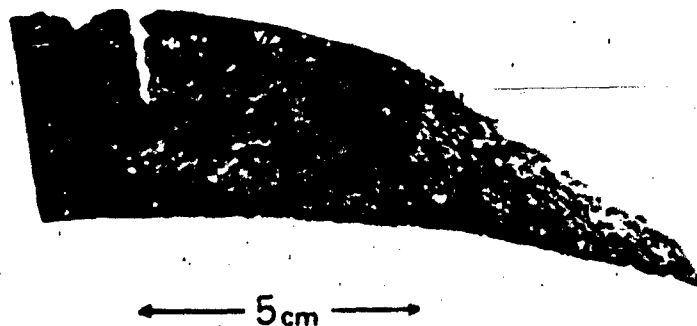
Pump impellers in hull and firemain pumps frequently suffer extensive erosion corrosion and cavitation damage in periods as short as three months (Figures 21 and 22).

Figure 22 Cavitation damage of bronze impeller vane.

The most common alloy used for impellers is G Bronze (UNS C90300). A program to find materials with greater erosion corrosion resistance has identified a cast chromium modified 70/30 copper nickel alloy similar to wrought UNS C71900¹⁴. Engineering trials have begun with an impeller made of this alloy, installed in a hull and firemain pump.

In addition, since the serviceable life of an impeller is not only related to the type of material used, but also to the operating conditions of the pump itself, ships' engineers are encouraged to operate their pumps more efficiently in order to reduce cavitation.

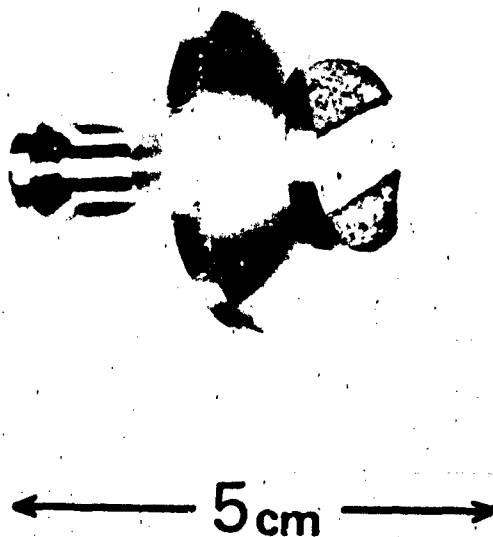
A fitting from the helo hauldown system or "Bear Trap" failed as a helicopter was being winched down onto the flight deck of a destroyer. The middle link of the assembly fractured at the hole where a shear pin was located. The shear pin itself did not break (Figure 24).

The link failed as a result of stress corrosion cracking. The susceptibility of the fitting to stress corrosion cracking was enhanced by its sensitized microstructure, which was the result of an incorrect heat treatment at the time of its manufacture¹⁶.

Figure 24 Failed martensitic stainless steel fitting from helo hauldown assembly.

Based on DREA's recommendation, all fittings were removed from service and given a corrective heat treatment. There have been no further failures to date.

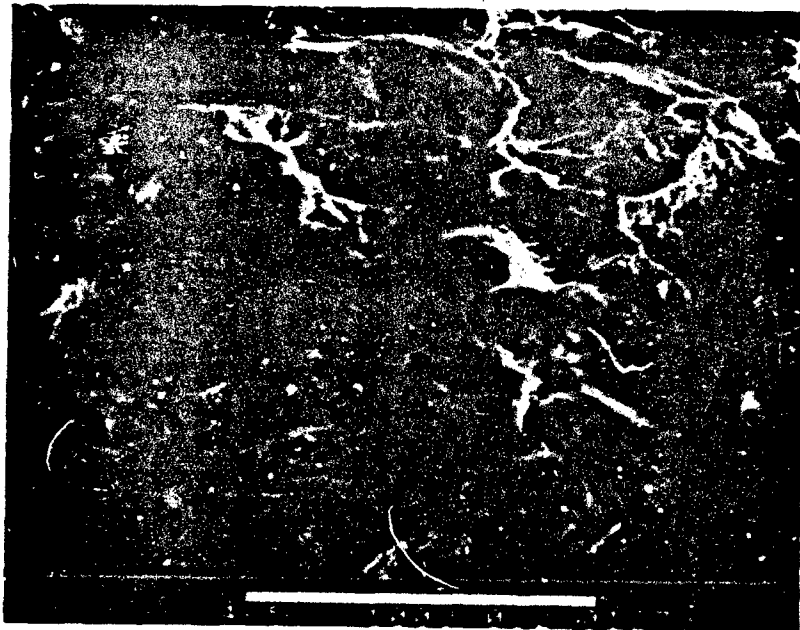
The fitting was made of martensitic stainless steel (UNS S43100) with a hardness of HRC 40. A fractographic examination revealed an intergranular fracture morphology (Figure 25), while a polished metallographic cross section showed a sensitized microstructure characterized by carbide precipitation along former austenitic grain boundaries (Figure 26).

Figure 25 SEM micrograph of intergranular fracture surface of failed fitting shown in Figure 24. X465

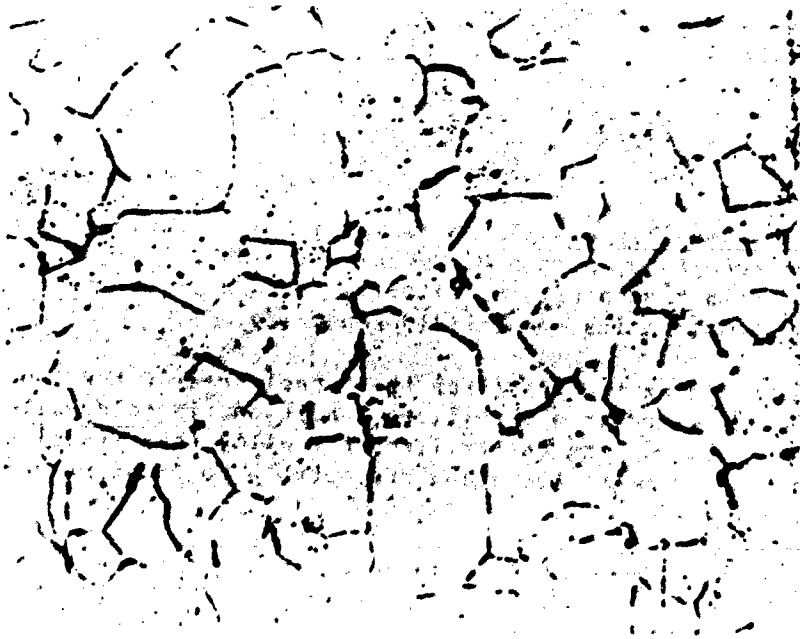
Figure 26 Metallograph of sensitized martensitic stainless steel fitting material showing carbide precipitation along former austenitic grain boundaries. X400

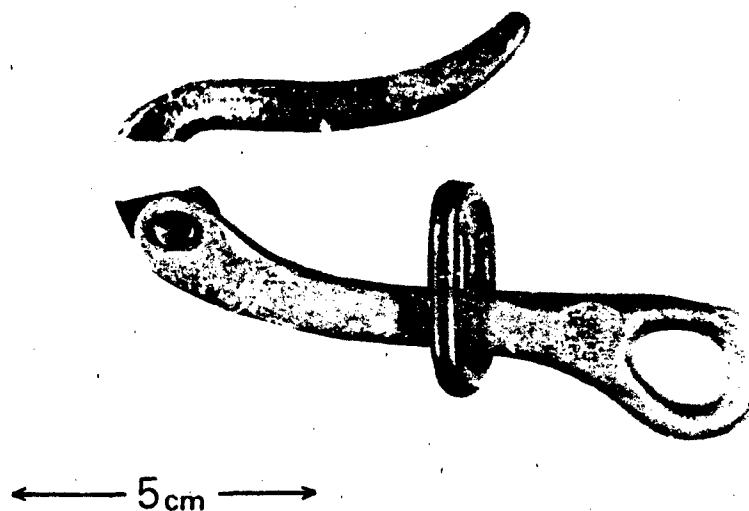
The pelican hook is part of the quick release mechanism for the twenty man life rafts carried on board Canadian Forces vessels. A hook on one of the life rafts failed unexpectedly (Figure 27).

The hook failed as a result of stress corrosion cracking of the high strength alloy (UNS C86300)¹⁷. This alloy is never recommended for use in a marine environment. An in situ examination was made of all hooks using eddy current instrumentation, to see if other hooks were manufactured from the two different alloys.

Figure 27 Failed manganese bronze pelican hook from twenty man life raft.

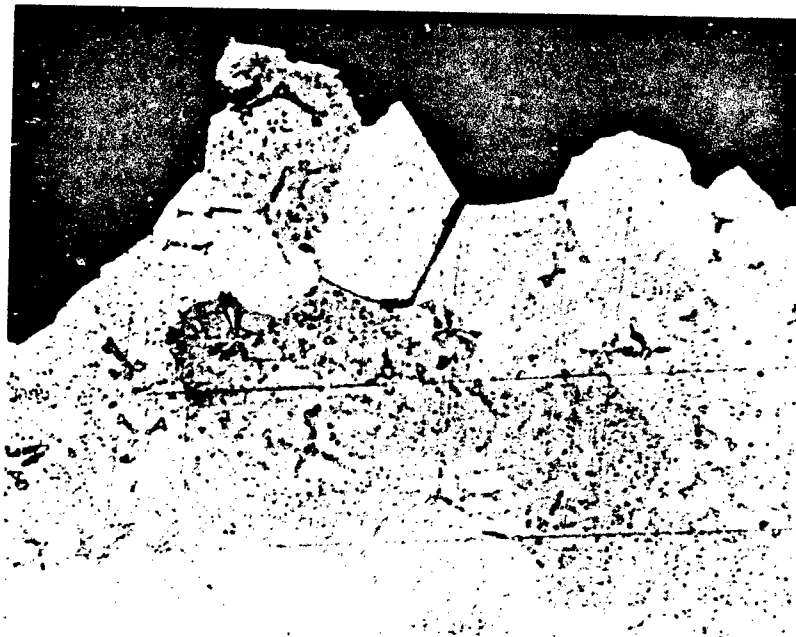
A chemical analysis of the two parts of the hook showed that one part was made of a manganese bronze alloy (UNS C86500) while the part that failed was made of a higher strength manganese bronze alloy (UNS C86300). A metallographic examination of each part revealed microstructures consistent with the chemical compositions. The UNS C86500 alloy had alpha needles in a beta matrix (HRB 75) while the UNS C86300 alloy had very little alpha phase in the beta matrix (HRB 92) (Figures 28 and 29). The fracture morphology of the surface was totally intergranular.

Figure 29

Metallograph of failed higher strength manganese bronze (UNS C86300) pelican hook material showing small amounts of alpha phase in beta matrix and intergranular fracture morphology. X310

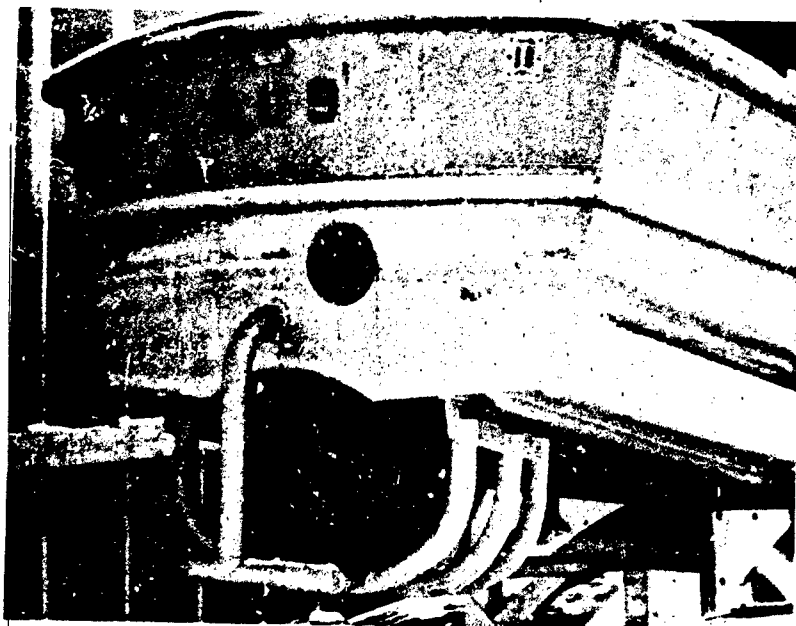
Severe corrosion has occurred on all of the aluminum hulled landing craft. However, the only area which has been attacked is the aft lower hull panels above the shaft and propellers (Figure 30).

Figure 30

Corrosion attack in tunnel area of aluminum hulled landing craft.
